Comme
PHASE I FINAL
CONTAMINATION ASSESSMENT REPORT
SECTION 22 - NONSOURCE AREA
(Version 3.1)

December 1987
Contract Number DAAK11-84-D0016
Task Number 14 (Army Sites North)

ENVIRONMENTAL SCIENCE AND ENGINEERING, INC.

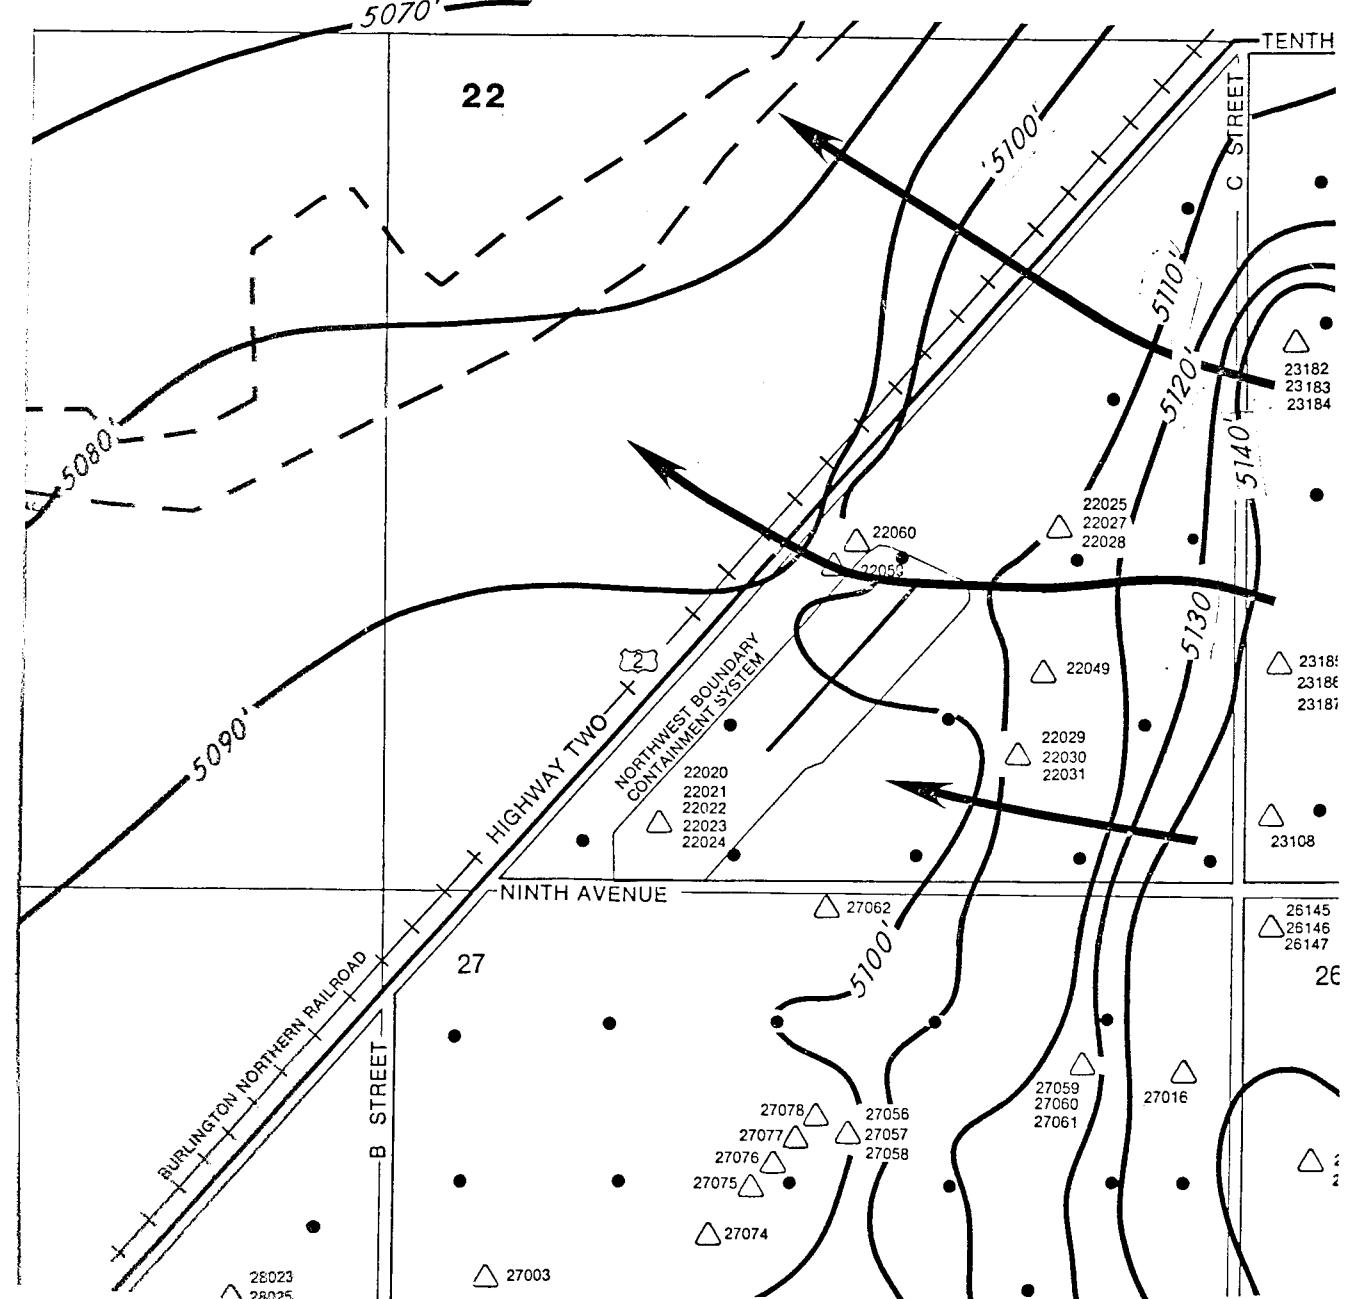
Figure 22-UNC-3
REGIONAL GROUND WATER FLOW
SECTION 22-UNC
ROCKY MOUNTAIN ARSENAL
SOURCE: ESE, 1987

The ground water contour map of Section 22-UNC (Figure 22-UNC-3) was generated from data collected in March 1986 (ESE, 1986c, RIC#86238R08). The map indicates that the water table occurs at an approximate depth of 30 ft (5,142 ft msl) at the southeastern corner and 35 ft (5,100 ft msl) at the northwestern boundary. Ground water flow is westward across Section 22-UNC, but changes to northwest near the RMA northwestern boundary. No Phase I boring penetrated the water table.

Ground water contamination was detected beneath Section 22-UNC during the Task 4 Initial Screening Program (ESE, 1986c, RIC#86238R08). Chloroform was detected in Wells 22020, 22021, 22022, 22059, and 27062, and dieldrin was detected in Wells 22059, 22060, and 27062. Diisopropylmethyl phosphonate (DIMP), dibromochloropropane (DBCP), and trichloroethane were detected in Well 27062. Benzene was detected in Well 22021. Wells 22025, 22029, and 22049 were dry during the initial sampling period. Data presented here are provided for background purposes and are not intended to be correlated with soil sample analytical results generated as part of the Phase I study. There is no indication that Section 22-UNC contributes to ground water contamination beneath this section. The migration of contaminants in the ground water beneath this section, however, is currently being assessed under Task 25.

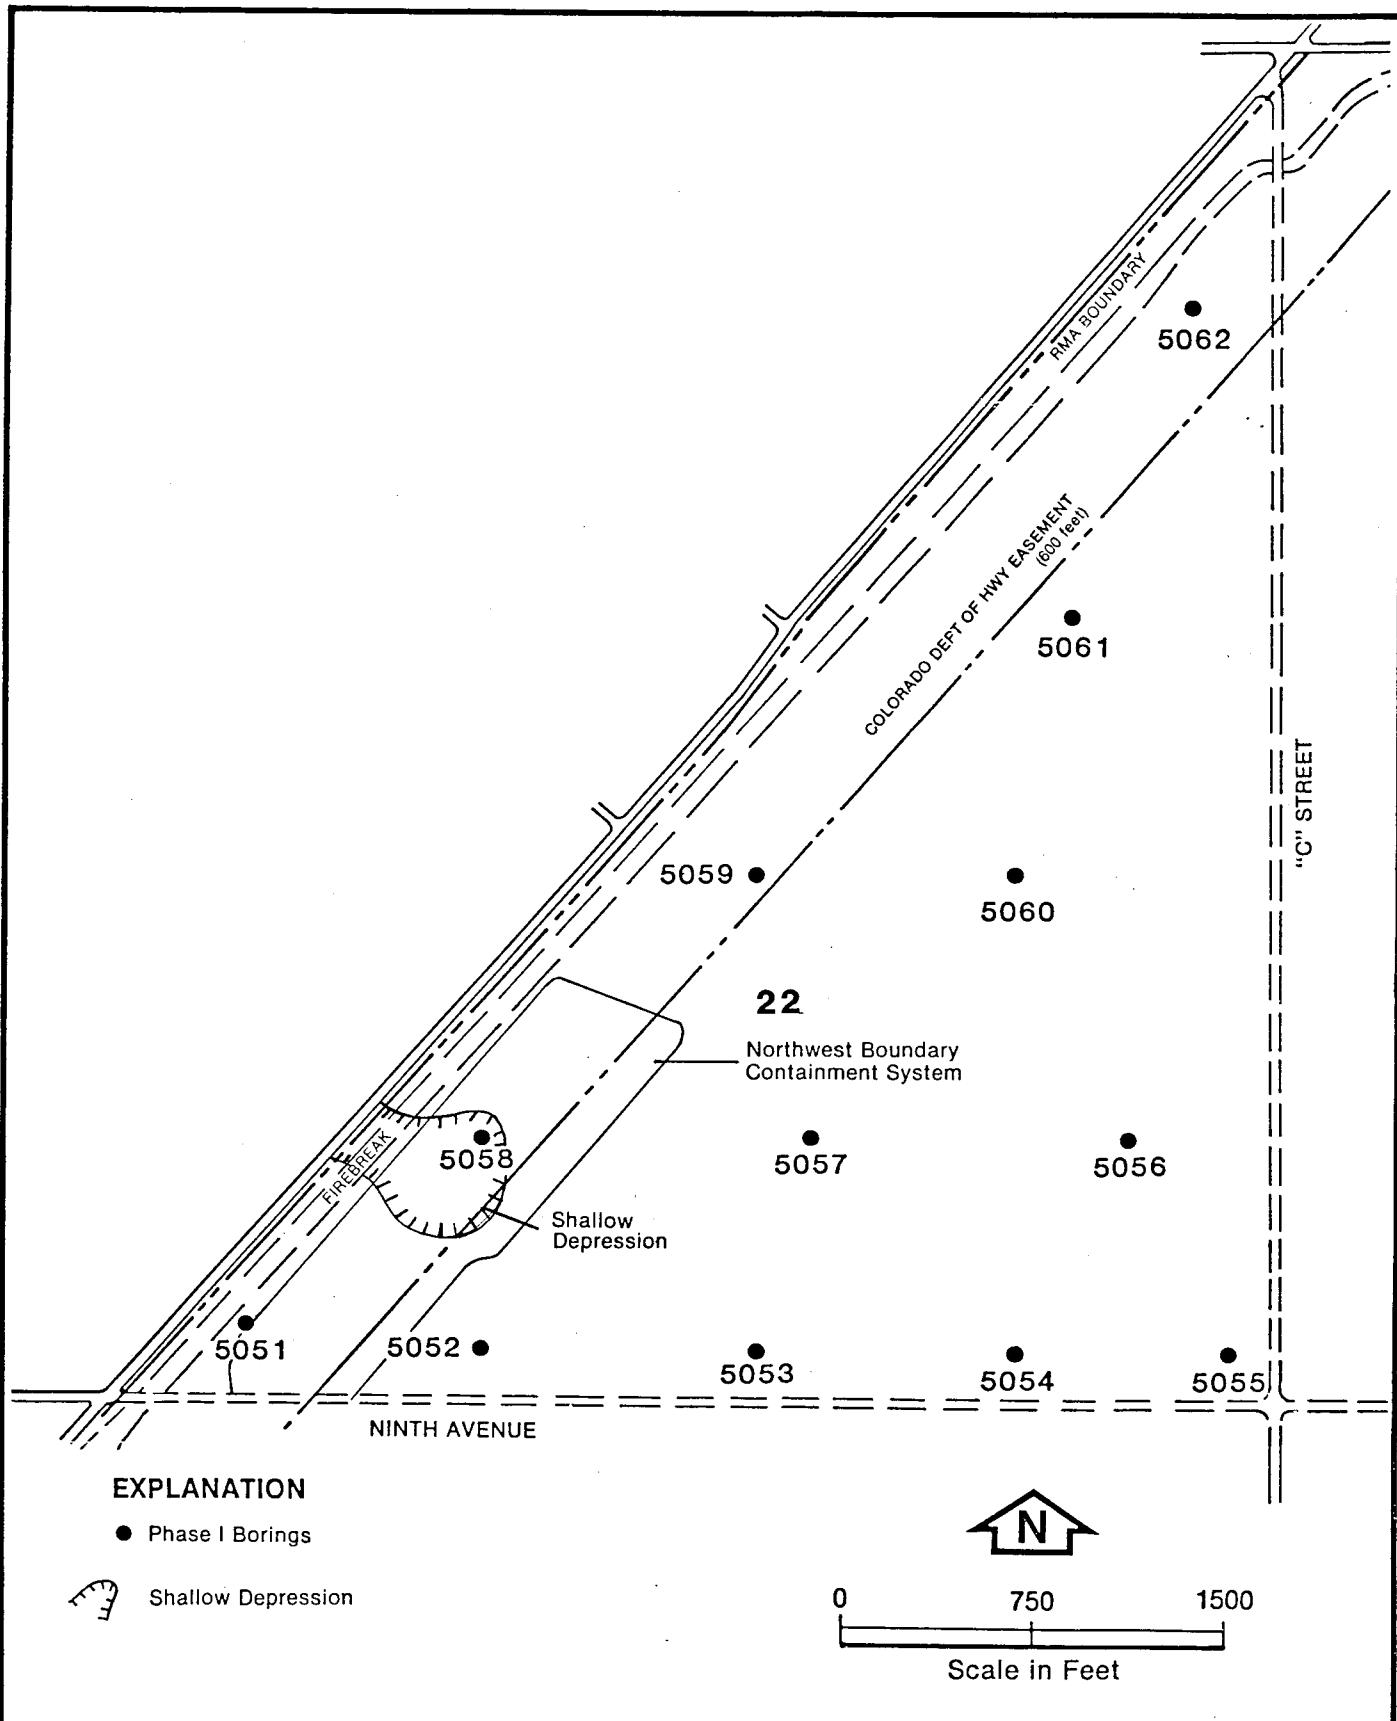
Figure 22-UNC-4
PHASE I INVESTIGATION
BORING LOCATION MAP
SECTION 22-UNC
SOURCE: ESE, 1987

Borehole spacing for this nonsource area was selected at 1,000 ft (Figure 22-UNC-4) based on historical information. All borings were drilled to a 5-ft depth using the continuous soil sampling method detailed in the Task 14 Technical Plan (ESE, 1986b, RIC#86238R04). Samples were composited in the laboratory from the 0- to 1- and 4- to 5- ft intervals unless field conditions [i.e., water table, staining, etc.] required an adjustment in procedure. All samples were taken at predetermined intervals in Section 22-UNC.

Prior to drilling, all boring sites were cleared for safety purposes in accordance with the geophysical program detailed in the Task 14 Technical Plan (ESE, 1986b, RIC#86238R04). A metal detector was used at all boring locations to survey the area for significant amounts of metal debris. If the metal detector indicated debris, the borehole clearance program was expanded to include a gradiometer survey. Significant metal debris was not detected at this section, and no boring locations were moved as a result of the geophysical program. Boring locations, pertinent surficial objects, and historical features from aerial photographs are presented on the boring location map (Figure 22-UNC-4).

Boring 5058 was drilled in the shallow depression noted near the center of the NWBCS. No unusual coloration indicative of disposal was visible in this or any other soil samples from Section 22-UNC.

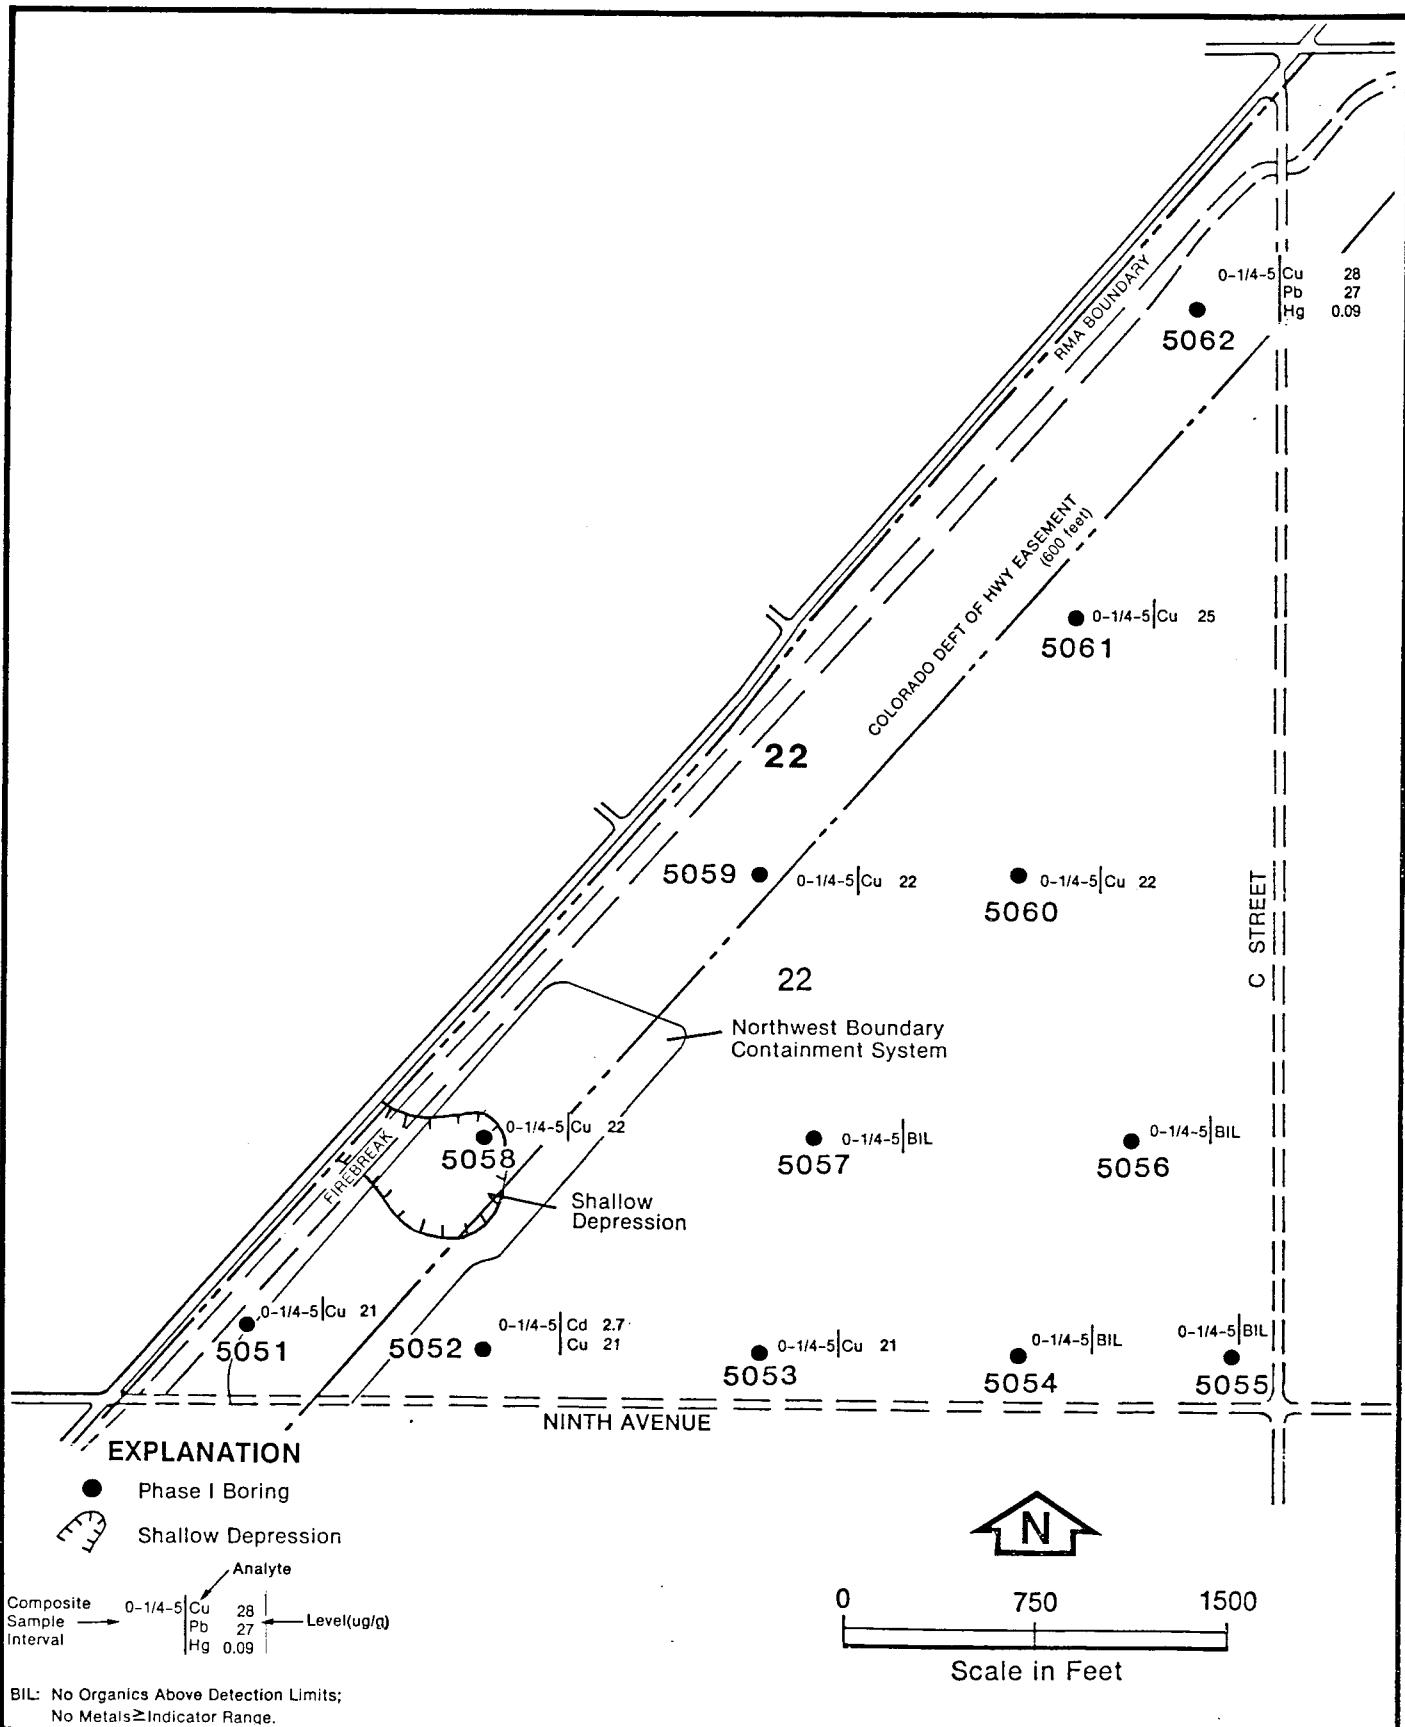
**Figure 22-UNC-5
PHASE I INVESTIGATION
CHEMICAL ANALYSIS RESULTS
SECTION 22-UNC**

Table 22-UNC-1 contains indicator ranges and a statistical summary of Phase I analytical results. A summary of analytical data for each sample, including lithology and air monitoring results, is presented in Table 22-UNC-2. A listing of the target compounds and a tabulation of analytical data can be found in Appendices 22-UNC-A and 22-UNC-B. Concentrations within or above indicator ranges for Phase I data are presented in Figure 22-UNC-5.

Of the 12 boreholes, one boring (5052) contained a cadmium level (2.7 ppm) above its indicator range (Table 22-UNC-2). The remainder of the samples

contained metal concentrations within or below their indicator ranges. Eight borings (5051, 5052, 5053, 5058, 5059, 5060, 5061, and 5062) contained copper between 20 and 28 ppm. These values are at the lower end of the indicator range and are probably natural occurrences. Mercury was detected in Boring 5062 at 0.091 ppm, which is in the upper end of the indicator range. Target organic compounds were not detected in any Section 22-UNC sample.
